The Costa Concordia accident after 6 years:

**PETITION FOR PARDON FOR CAPTAIN SCHETTINO, SERVING TIME 16+ YEARS IN PRISON.
ITALY MUST STOP THE UNFAIR CRIMINALISATION OF THE CAPTAIN.**

The Italian trial and conviction of Costa Concordia's captain Schettino:
Italian report reveals serious breach of IMO and EU directives by the Italian Court.

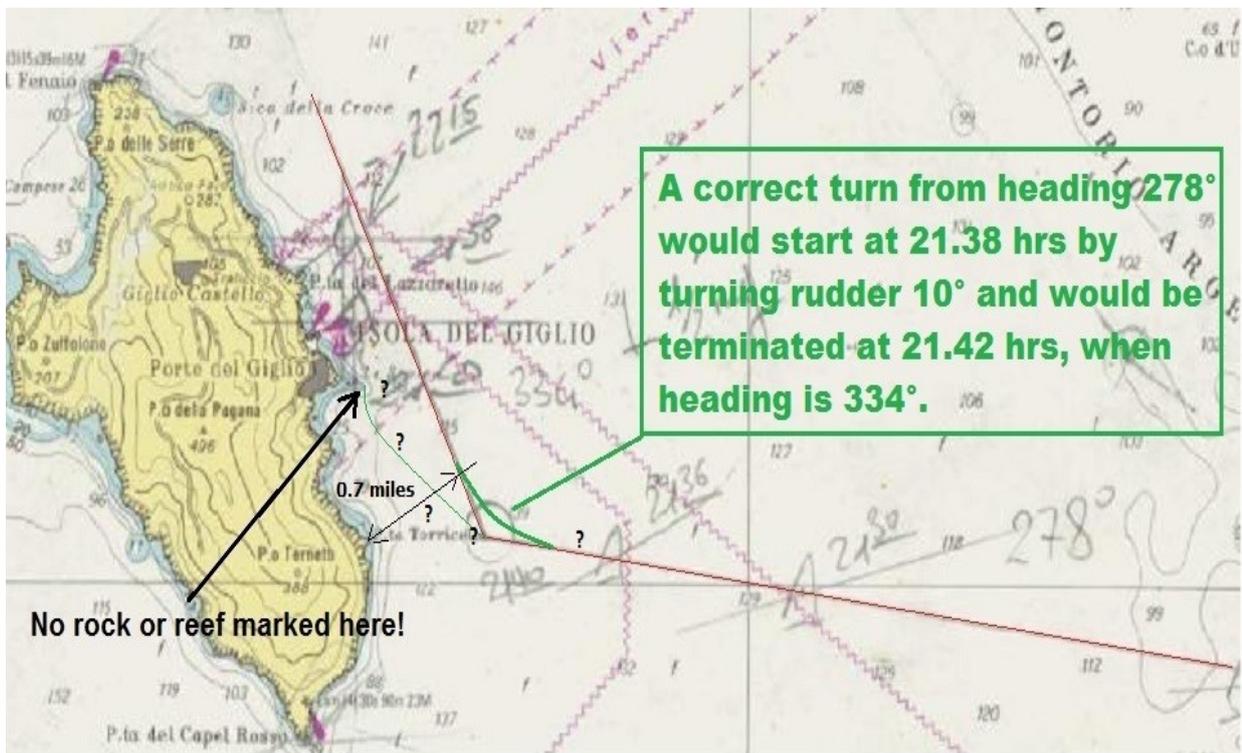
He has made a graphical assessment of the by-pass navigation, and is commenting the navigation planning, execution and tracking by a reconstruction of the voyage planning, as follows:

“The report does not say what events were planned and how these events were executed, but it appears that a change of course from 278 degrees to 334 degrees was planned at 21.42 hrs.
